AN INVESTIGATION OF ELECTROCHEMICAL TECHNIQUES  
DESIGNED TO MITIGATE THE CORROSION OF STEEL IN  
HISTORIC REINFORCED CONCRETE STRUCTURES:  
FRANK LLOYD WRIGHT'S FREEMAN HOUSE, HOLLYWOOD, CA

A THESIS

Historic Preservation

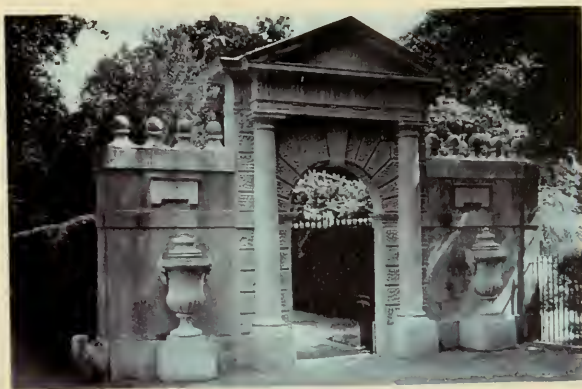
Inigo Jones Gateway after the application of an impressed current cathodic protection system. Photo from Blackney and Martin, *Metals*, Volume 1 (April 1998) p. 93.

The Inigo Jones gateway was built for Beaufort House (ca. 1621) in Chelsea and, subsequently, moved to Chiswick House, London in 1738 by Richard Boyle, Third Earl of Burlington. The stone of the gatehouse is joined with wrought iron cramps that were corroding and causing the stone to fracture. Previous repairs included the application of a dense, impermeable mortar over the deteriorated stone surface. Removal of the mortar and dismantling of the structure would have resulted in unacceptable loss of original material. Instead, a method of non-destructive electrochemical rehabilitation, impressed current cathodic protection (ICCP), was explored for use on the structure.<sup>16</sup> Work began with trials in 1992 and culminated with full implementation in 1995. Figure 2 shows the Inigo Jones Gateway after the application of the ICCP system.

A “keyhole” system was developed to provide access to the iron cramps located at a depth of 230 mm. Holes, each 10 mm in diameter, were drilled through the masonry to the cramps. A steel sleeve was placed in the hole and a smaller diameter drill (2.3 mm) used to drill an 8 mm deep hole into each cramp. Plastic-coated wires were soldered onto “banana” plugs and the plugs painted with conductive silver-rich paint. The plugs were then inserted into the steel sleeve and pushed into the iron cramp. The sleeve was then withdrawn leaving the plug and wires in place.

These leads, along with reference electrodes and anodes, were fed to an underground conduit through existing mortar joints or channels cut into repair mortars. The conduit runs approximately 60 meters to Chiswick House where the wires are connected to the power source and monitoring equipment. Continuous monitoring of the cramp’s electro-potential can be further refined to include the use of data loggers to record the output voltage and cramp potentials relative to climatic change and consequential masonry wetting and drying cycles.

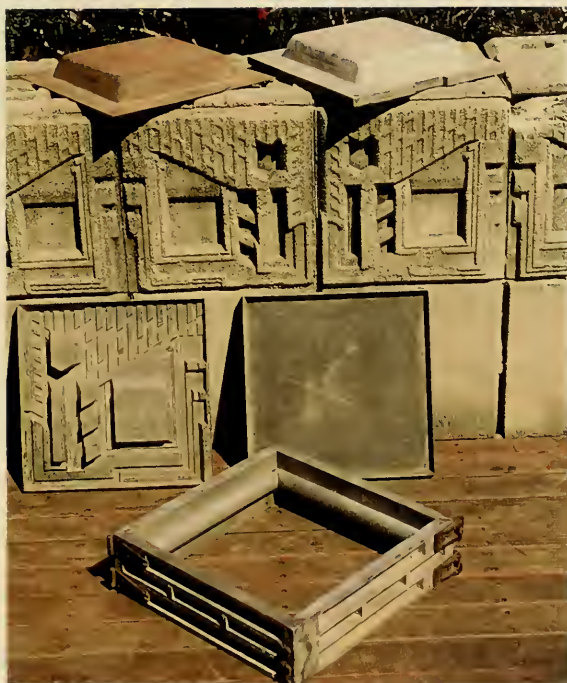
Figure 8  
Cast concrete block production mold.  
Photograph courtesy of the Freeman House.

The textile blocks were fabricated on a 4' by 6' iron-top table set up on the hillside west of the house. Sand and cement was mixed (4 to 1) dry twice in a wooden box with a hoe. Just enough water was added so that the material held its shape. The form was filled with a shovel full of mix and the top wiped off with a stick. The top plate was put in place, followed by a 2 x 4 on top of the form. The 2 x 4 was struck several times with a 6

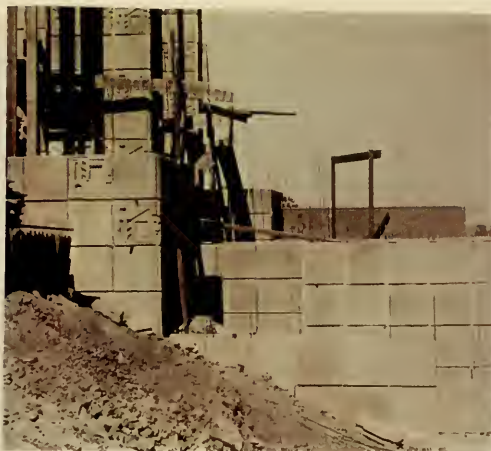
Figure 11

Freeman House construction photo showing placement of vertical reinforcing rod. Courtesy of the Freeman House.

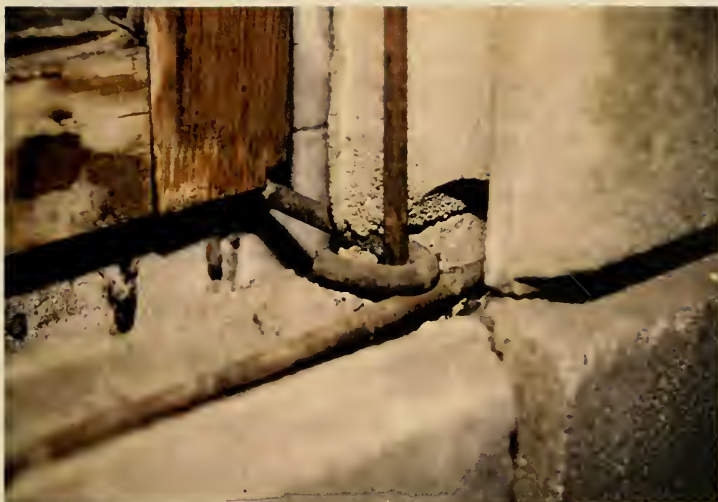
Figure 12  
Tie-rod connecting inner and outer wythe.  
Photograph courtesy of K. Fong.

As the blocks were stacked, the two wythes were tied together with smooth steel rod looped around the reinforcing rod. The ties were not encapsulated in grout. Figures 12 and 13 show examples of the ties that connect the wythes.

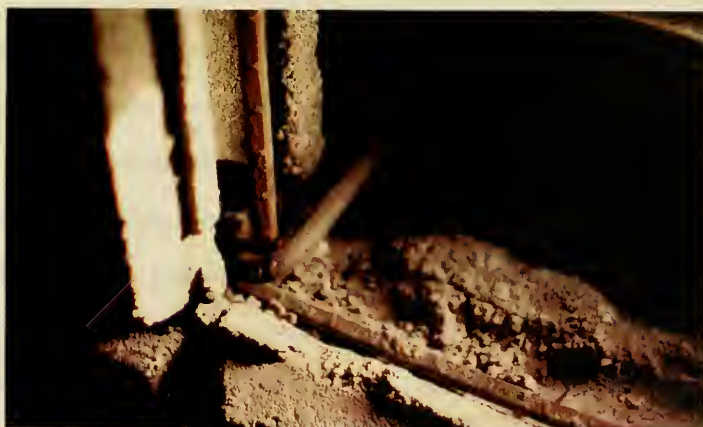
Figure 13  
Tie-rod connecting inner and outer wythe.

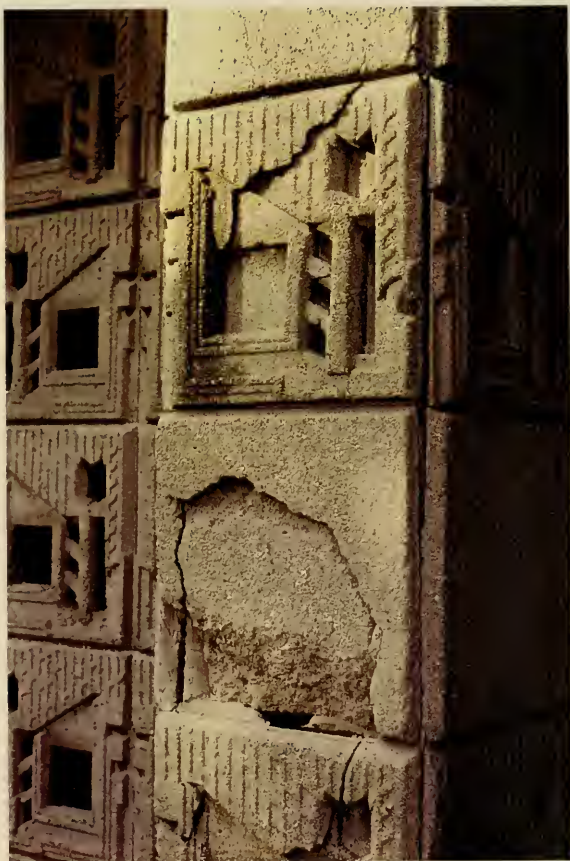
Figure 14  
Ring fracture of concrete block on south facade.

While greater rigidity of the structure may have been achieved, the lean 1:4 ratio of cement to sand yielded extremely weak and porous blocks. The cement content was insufficient to bond all of the aggregate. The blocks are, therefore, more susceptible to deterioration due to weathering, water infiltration, and accelerated carbonation.

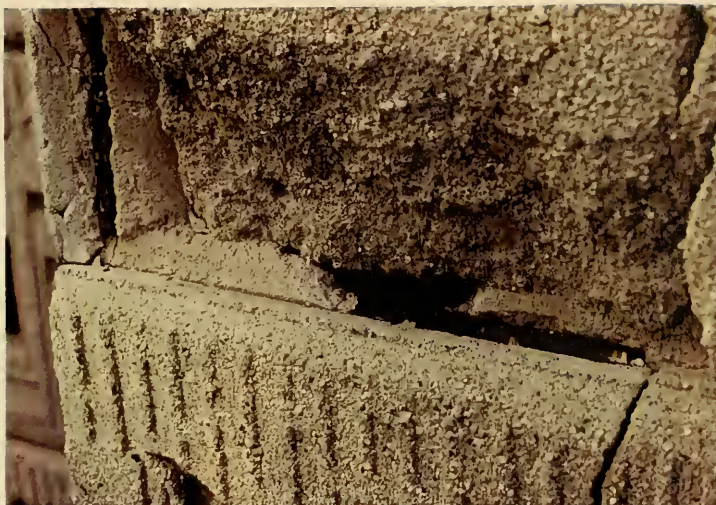
Figure 15  
Detail of ring fracture of concrete block on south facade.

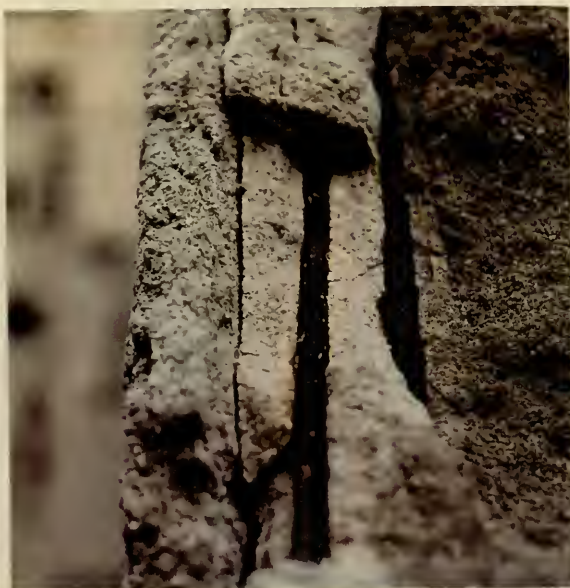
Figure 16  
Detail of ring fractured corner block on the south facade.  
Two vertical reinforcing rods are visible.

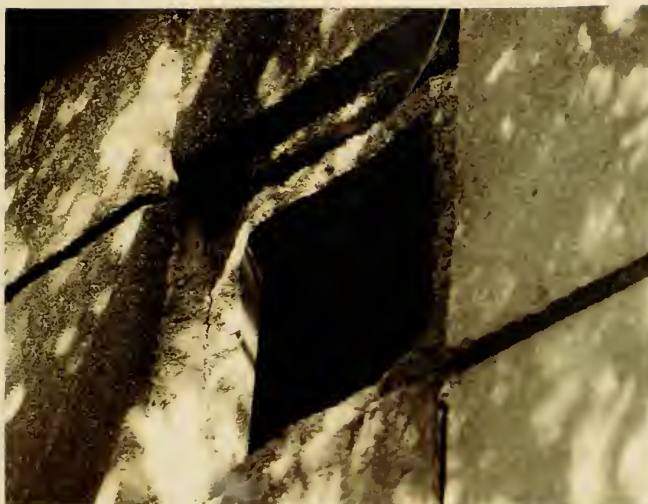
Figure 17  
Ring fracture of concrete block on south facade.

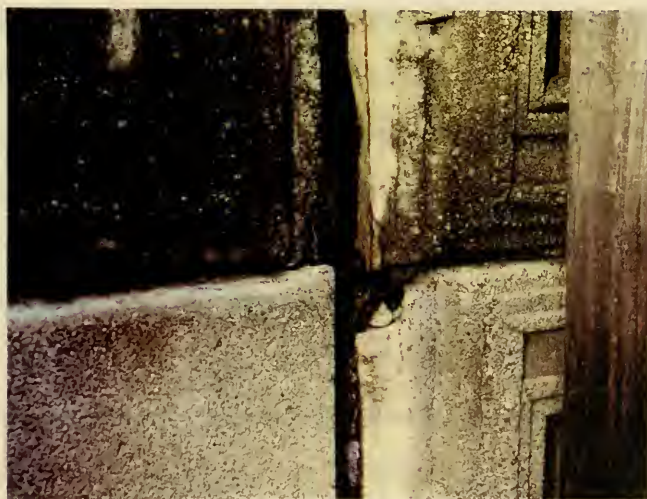
Figure 18  
Detail of the intersection of four concrete blocks on the south facade.

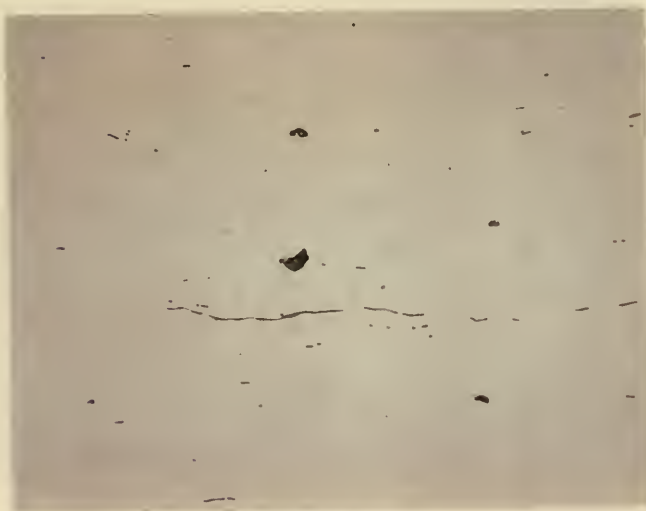
Figure 36  
Optical micrograph of Freeman House rebar shown in a longitudinal section showing typical inclusions. (unetched @ 600x magnification)

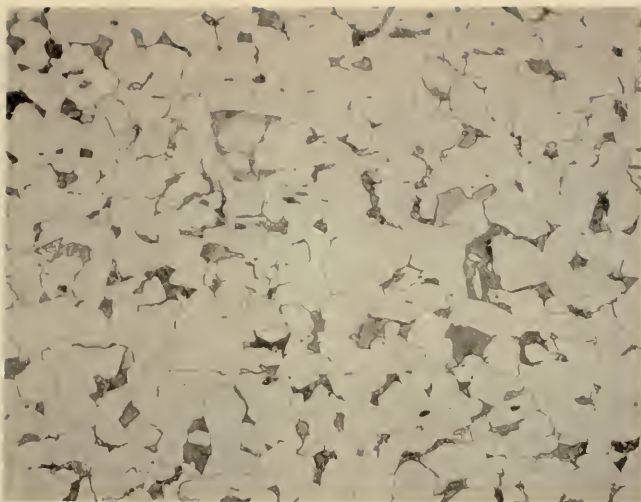
Figure 37

Optical micrograph of Freeman House rebar shown in a longitudinal section. The hot-rolled structure is pearlite plus ferrite, with approximately 0.2% carbon. (2% nital etch @ 600x magnification)

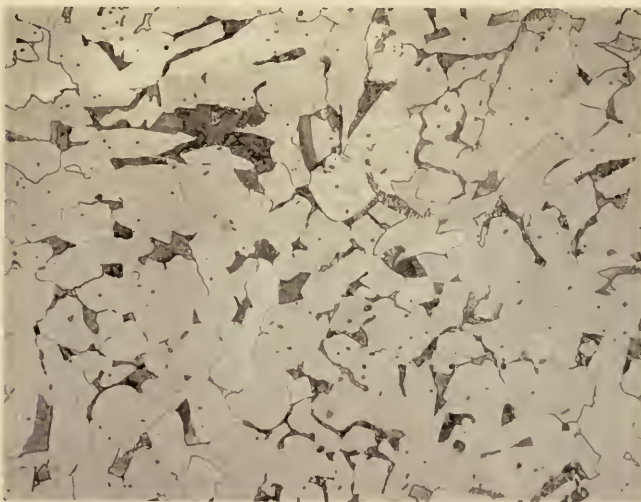
Figure 38

Optical micrograph of Freeman House rebar shown in a transverse section. The hot-rolled structure is pearlite plus ferrite, with approximately 0.2% carbon. (2% nital etch @ 600x magnification)

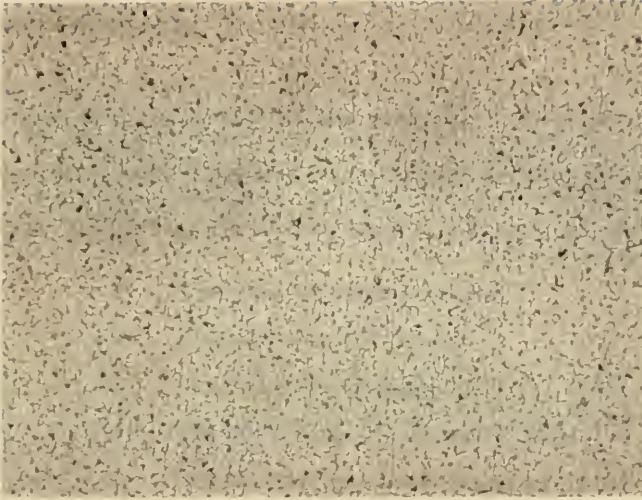
Figure 39

Optical micrograph of Freeman House rebar shown in a longitudinal section.  
ASTM grain size is 10. (2% nital etch @ 100x magnification)

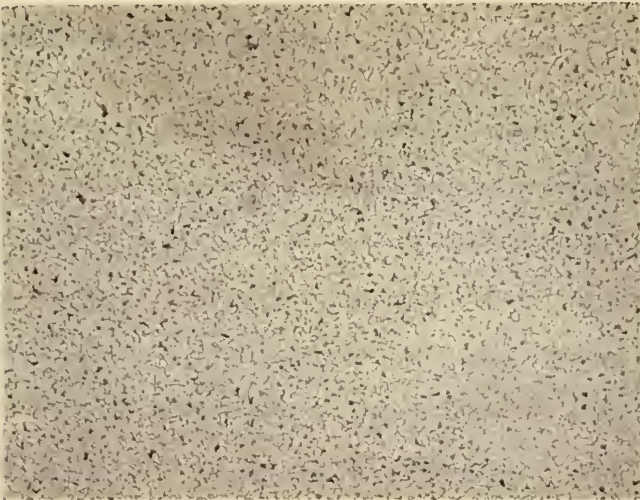
Figure 40

Optical micrograph of Freeman House rebar shown in a transverse section.  
ASTM grain size is 10. (2% nital etch @ 100x magnification)
